**Flood Control Project Maintenance  
Levee Inspections**

**Fall 2019 Levee Maintenance Deficiency Summary Report**

**Sacramento River Basin**

**Sacramento Maintenance Yard Maintenance Area 0009**

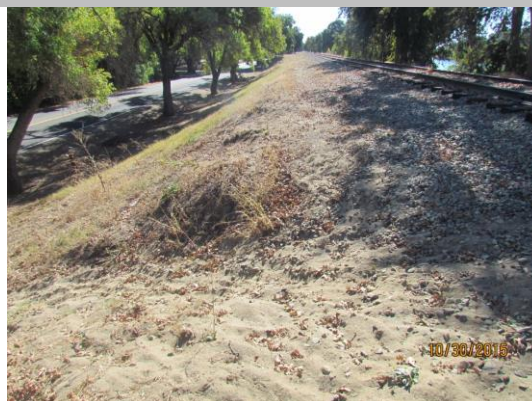
Photo 1 of 1 : FA\_2019\_MA0009\_201\_368\_20190904\_00263.jpg

LM Start	10.15	Rating **	M	Issue No.	368
LM End	10.15	Issue Type +	Ma	Location *	LS
Category	Earthen Levee			GPS Latitude/Longitude	
				Start	End
Item	Slope Stability			38.449967 °	38.449967 °
				-121.500053 °	-121.500053 °
DWR ID	DWR_MA0009_01_f_2015_368				
Comment Code					
S2 : Repair the levee slope damaged by foot traffic and prevent access where possible.					
Inspector Comment

View of the slope stability on the landward side of the levee looking downstream. Fall 2015.

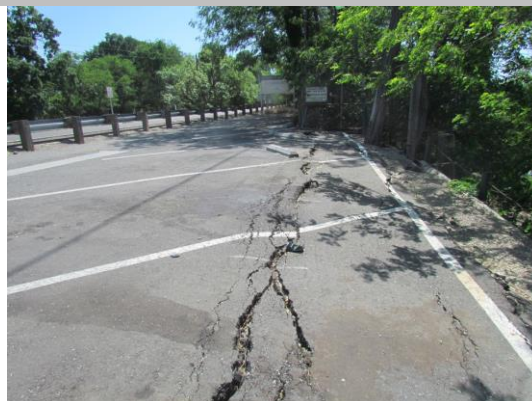
Photo 1 of 1 : FA\_2019\_MA0009\_201\_309\_20190904\_00213.jpg

LM Start	10.54	Rating **	M	Issue No.	309
LM End	10.54	Issue Type +	Ob	Location *	WS
Category	Earthen Levee			GPS Latitude/Longitude	
				Start	End
Item	Cracking			38.444353°	38.444353°
				-121.500472°	-121.500472°
DWR ID	DWR_MA0009_01_s_2015_309				
Comment Code					
CR1 : Monitor and have inspected by geotechnical engineer.					
Inspector Comment

View of the crack on the water ward side of the levee looking downstream. Spring 2015.

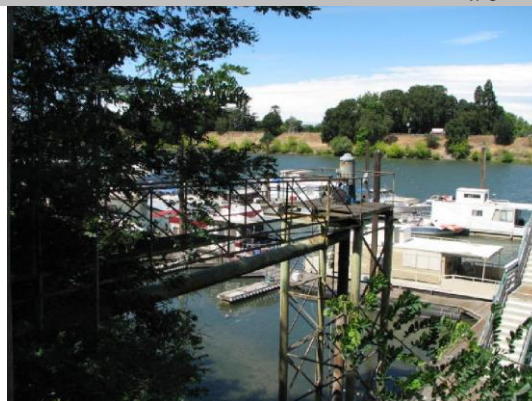
Photo 1 of 3 : UCIP\_FA\_2019\_9443\_16422.jpg

LM Start	10.56	Rating **	M	Issue No.	1814	
LM End	10.56	Issue Type +	En	Location *		
Category	Supplemental			GPS Latitude/Longitude		
				Start	End	
Item	DRAFT DWR UCIP Field Study			38.444136 °	38.444136 °	
				-121.500414 °	-121.500414 °	
DWR ID	18957					
Comment Code						
Inspector Comment						
DS_ID:18957 FS_ID:9443 EP_NO: N/A Repair Type: Non-Urgent Crossing Status: Found UCIP Comments: No permit identified for this crossing. FIELD_STRUCT_DESC: 14-inch steel irrigation pipe through the levee, 3.5 feet below the crown. Pump on elevated pier with elevated walkway on the waterside (WS) shoulder. 48-inch concrete distribution box on the landside (LS) toe. (Permit No. 1629, 1952 - C. A. Beach). FS Date: 6/22/2012 3:46:00 PM

Pump on elevated pier on WS.

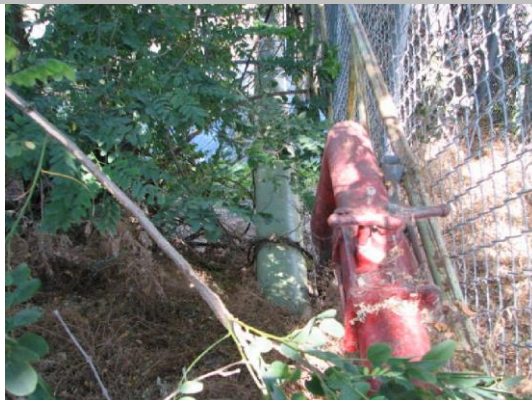
Photo 3 of 3 : UCIP\_FA\_2019\_9443\_16424.jpg

LM Start	10.56	Rating **	M	Issue No.	1814 (cont)	
LM End	10.56	Issue Type +	En	Location *		
Category	Supplemental			GPS Latitude/Longitude		
				Start	End	
Item	DRAFT DWR UCIP Field Study			38.444136 °	38.444136 °	
				-121.500414 °	-121.500414 °	
DWR ID	18957					
Comment Code						
Inspector Comment						
DS_ID:18957 FS_ID:9443 EP_NO: N/A Repair Type: Non-Urgent Crossing Status: Found UCIP Comments: No permit identified for this crossing. FIELD_STRUCT_DESC: 14-inch steel irrigation pipe through the levee, 3.5 feet below the crown. Pump on elevated pier with elevated walkway on the waterside (WS) shoulder. 48-inch concrete distribution box on the landside (LS) toe. (Permit No. 1629, 1952 - C. A. Beach). FS Date: 6/22/2012 3:46:00 PM

Pipe, Fire Connection, and Fenced in Walway on WS shoulder.

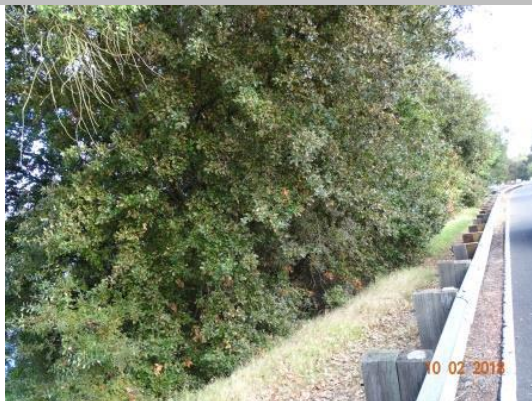
Photo 1 of 1 : FA\_2019\_MA0009\_201\_310\_20190904\_00214.jpg

LM Start	10.58	Rating **	M	Issue No.	310
LM End	10.58	Issue Type +	Ma	Location *	WS
Category	Earthen Levee			GPS Latitude/Longitude	
				Start	End
Item	Trim / Thin Trees			38.443880 °	38.443880 °
				-121.500545 °	-121.500545 °
DWR ID	DWR_MA0009_01_s_2015_310				
Comment Code					
T3 : Trim and thin trees to allow visibility of the ground and room to flood fight.					
Inspector Comment

View of dense trees along waterside slope. Fall 2018

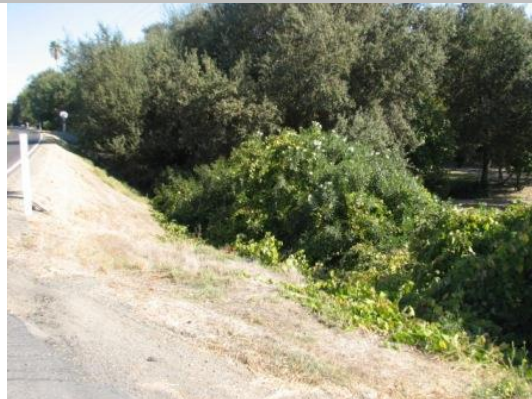
Photo 1 of 2 : FA\_2019\_MA0009\_201\_220\_20190904\_00140.jpg

LM Start	<b>10.74</b>	Rating **	M	Issue No.	<b>220</b>
LM End	<b>10.77</b>	Issue Type +	En	Location *	LS
Category	Earthen Levee		GPS Latitude/Longitude		
			Start	End	
Item	Vegetation		38.441645°	38.441133°	
			-121.501405°	-121.501632°	
DWR ID	DWR_MA0009_01_s_2012_220				
Comment Code					
V6 : Landscaping					
Inspector Comment

The overgrown landscape blocks visibility. Fall 2013

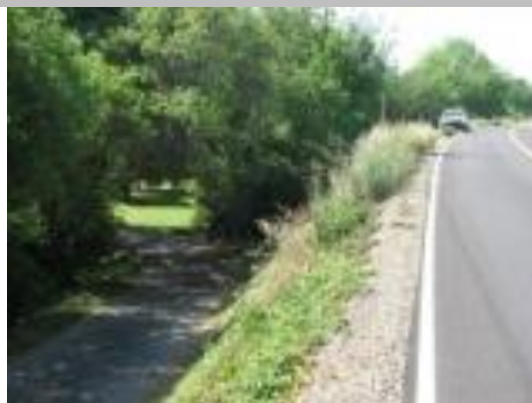
Photo 2 of 2 : FA\_2019\_MA0009\_201\_220\_20190904\_00141.jpg

LM Start	10.74	Rating **	M	Issue No.	220 (cont)	
LM End	10.77	Issue Type +	En	Location *	LS	
Category	Earthen Levee			GPS Latitude/Longitude		
				Start		End
Item	Vegetation			38.441645 °		38.441133 °
				-121.501405 °		-121.501632 °
DWR ID	DWR_MA0009_01_s_2012_220					
Comment Code						
V6 : Landscaping						
Inspector Comment

A view of the driveway and landscape. Photo taken spring 2012.

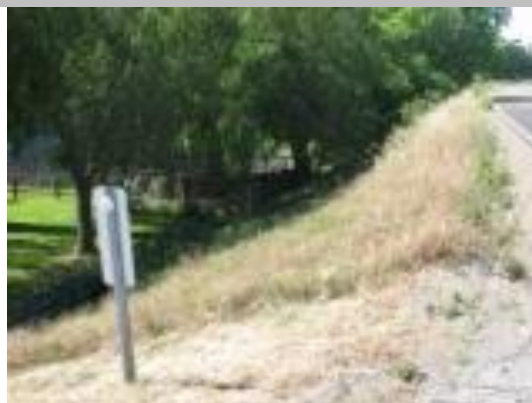
Photo 1 of 1 : FA\_2019\_MA0009\_201\_219\_20190904\_00139.jpg

LM Start	10.80	Rating **	M	Issue No.	219
LM End	10.82	Issue Type +	En	Location *	LS
Category	Earthen Levee			GPS Latitude/Longitude	
				Start	End
Item	Vegetation			38.440778 °	38.440577 °
				-121.501957 °	-121.502058 °
DWR ID	DWR_MA0009_01_s_2012_219				
Comment Code					
V6 : Landscaping					
Inspector Comment

A view of the horse corral and some landscape. Photo taken spring 2012.

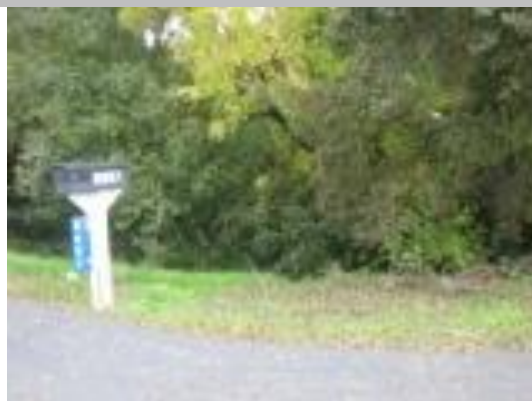
Photo 1 of 1 : FA\_2019\_MA0009\_201\_161\_20190904\_00089.jpg

LM Start	10.95	Rating **	M	Issue No.	161
LM End	10.95	Issue Type +	En	Location *	LS
Category	Earthen Levee			GPS Latitude/Longitude	
				Start	End
Item	Vegetation			38.439031 °	38.439031 °
				-121.503463 °	-121.503463 °
DWR ID	DWR_MA0009_01_f _ 2012_161				
Comment Code					
V6 : Landscaping					
Inspector Comment

Landscape planted at toe of levee. Fall 2012

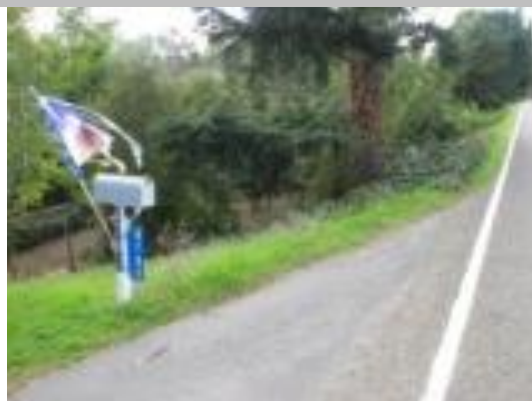
Photo 1 of 1 : FA\_2019\_MA0009\_201\_160\_20190904\_00088.jpg

LM Start	10.96	Rating **	M	Issue No.	160
LM End	10.96	Issue Type +	En	Location *	LS
Category	Earthen Levee			GPS Latitude/Longitude	
				Start	End
Item	Vegetation			38.438883 °	38.438883 °
				-121.503654 °	-121.503654 °
DWR ID	DWR_MA0009_01_f_2012_160				
Comment Code					
V6 : Landscaping					
Inspector Comment

Groundcover and shrubs on the slope and toe of levee. Fall 2012

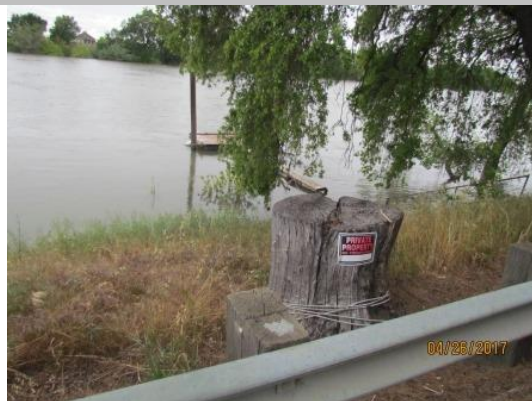
Photo 1 of 1 : FA\_2019\_MA0009\_201\_306\_20190904\_00212.jpg

LM Start	11.02	Rating **	N	Issue No.	306
LM End	11.02	Issue Type +	Ma	Location *	WS
Category	Earthen Levee			GPS Latitude/Longitude	
				Start	End
Item	Trim / Thin Trees			38.438314 °	38.438314 °
				-121.504306 °	-121.504306 °
DWR ID	DWR_MA0009_01_s_2017_306				
Comment Code					
T5 : Tree stumps.					
Inspector Comment

View of stump on waterside levee slope. Spring 2017.

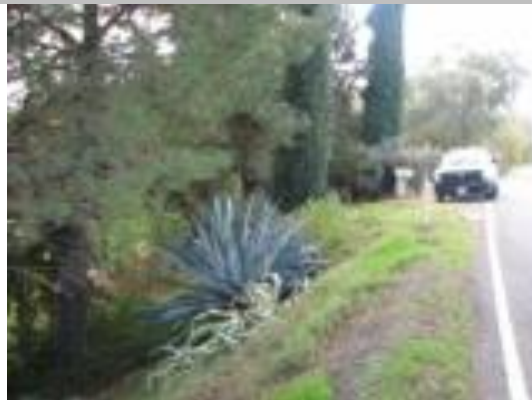
Photo 1 of 1 : FA\_2019\_MA0009\_201\_154\_20190904\_00082.jpg

LM Start	11.03	Rating **	M	Issue No.	154
LM End	11.05	Issue Type +	En	Location *	LS
Category	Earthen Levee			GPS Latitude/Longitude	
				Start	End
Item	Vegetation			38.438178 °	38.437998 °
				-121.504409 °	-121.504767 °
DWR ID	DWR_MA0009_01_f_2012_154				
Comment Code					
V6 : Landscaping					
Inspector Comment

Agave and shrubs planted on levee slope. Fall 2012

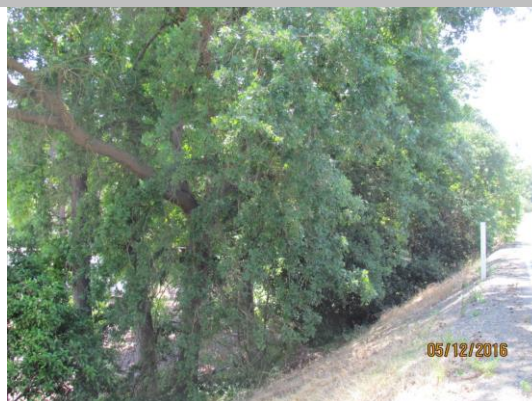
Photo 1 of 1 : FA\_2019\_MA0009\_201\_72\_20190904\_00029.jpg

LM Start	11.19	Rating **	M	Issue No.	72
LM End	11.19	Issue Type +	En	Location *	LS
Category	Earthen Levee			GPS Latitude/Longitude	
				Start	End
Item	Vegetation			38.436735 °	38.436735 °
				-121.506647 °	-121.506647 °
DWR ID	DWR_MA0009_01_f_2012_72				
Comment Code					
V6 : Landscaping					
Inspector Comment

View of the landscape on the landward side of the levee looking downstream. Spring 2016.

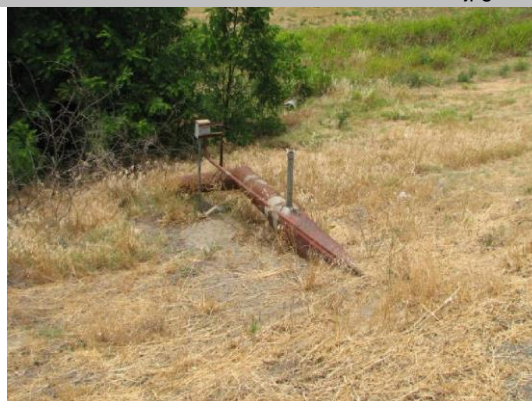
Photo 1 of 3 : UCIP\_FA\_2019\_5129\_6861.jpg

Comment Code					
Inspector Comment					
DS_ID:17457					
FS_ID:5129					
EP_NO: N/A					
Repair Type: Non-Urgent					
Crossing Status: Found					
UCIP Comments: Determine if this pipe is grouted in place.					
FIELD_STRUCT_DESC: *ABANDONED* 14-inch pipe through levee, 5.0 feet below-crown. Pump and butterfly valve in pump house on waterward slope. 1.5-inch galvanized steel pipe 5-feet below crown provides electricity. 36-inch Concrete standpipe on LS toe. Permit No. 1215, 1947. included in O+M manual (1955). May have been grouted in place as there are grouting standpipes on both the LS and WS shoulder.					
FS Date: 6/22/2012 2:48:01 PM

14-inch steel pipe on LS slope with 36-inch concrete standpipe in trees at toe.

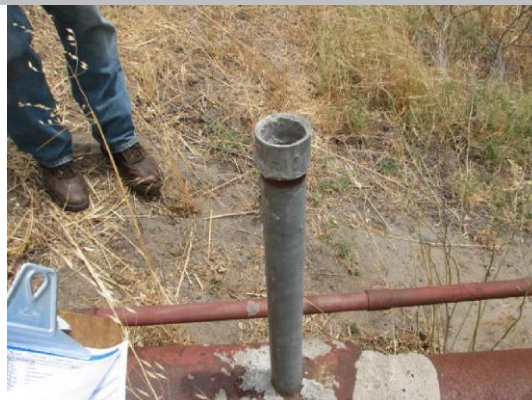
Photo 2 of 3 : UCIP\_FA\_2019\_5129\_6860.jpg

Grouting attachment at LS.

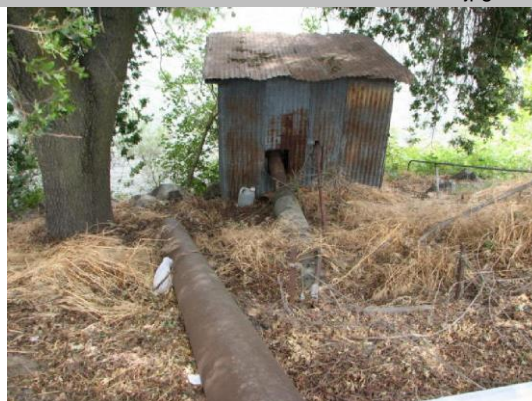
Photo 3 of 3 : UCIP\_FA\_2019\_5129\_6859.jpg

LM Start	11.23	Rating **	M	Issue No.	1815 (cont)	
LM End	11.23	Issue Type +	En	Location *		
Category	Supplemental			GPS Latitude/Longitude		
				Start	End	
Item	DRAFT DWR UCIP Field Study			38.436370 °	38.436370 °	
				-121.507300 °	-121.507300 °	
DWR ID	17457					
Comment Code						
Inspector Comment						
DS_ID:17457 FS_ID:5129 EP_NO: N/A Repair Type: Non-Urgent Crossing Status: Found UCIP Comments: Determine if this pipe is grouted in place. FIELD_STRUCT_DESC: *ABANDONED* 14-inch pipe through levee, 5.0 feet below-crown. Pump and butterfly valve in pump house on waterward slope. 1.5-inch galvanized steel pipe 5-feet below crown provides electricity. 36-inch Concrete standpipe on LS toe. Permit No. 1215, 1947. included in O+M manual (1955). May have been grouted in place as there are grouting standpipes on both the LS and WS shoulder. FS Date: 6/22/2012 2:48:01 PM

pipe and pumphouse on WS slope

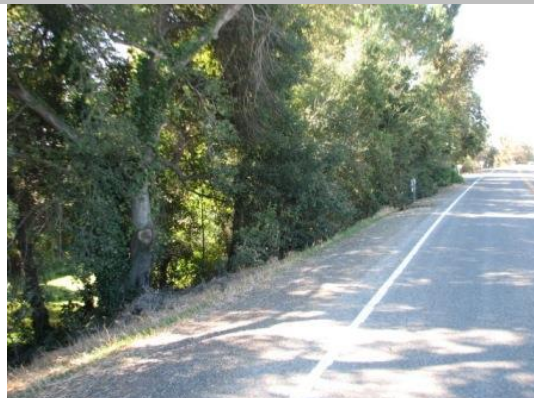
Photo 1 of 2 : FA\_2019\_MA0009\_201\_212\_20190904\_00136.jpg

LM Start	11.33	Rating **	M	Issue No.	212
LM End	11.33	Issue Type +	En	Location *	LS
Category	Earthen Levee			GPS Latitude/Longitude	
				Start	End
Item	Vegetation			38.435647 °	38.435647 °
				-121.508891 °	-121.508891 °
DWR ID	DWR_MA0009_01_s_2012_212				
Comment Code					
V6 : Landscaping					
Inspector Comment

Vegetation on the levee slope partially blocks visibility. Fall 2013

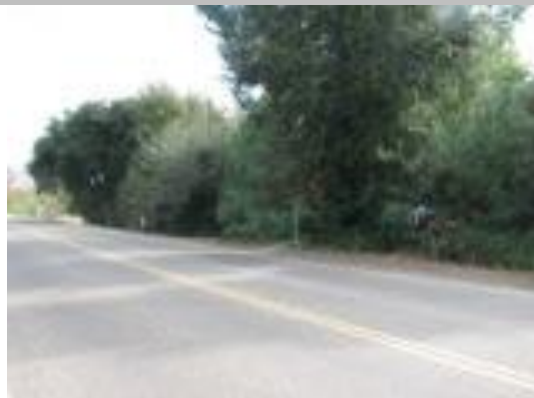
Photo 2 of 2 : FA\_2019\_MA0009\_201\_212\_20190904\_00137.jpg

The landscaping is planted on the levee slope and shoulder. Fall 2011

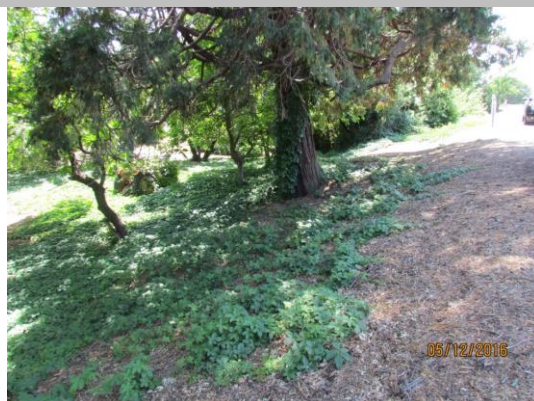
Photo 1 of 1 : FA\_2019\_MA0009\_201\_211\_20190904\_00135.jpg

LM Start	11.37	Rating **	M	Issue No.	211
LM End	11.37	Issue Type +	En	Location *	LS
Category	Earthen Levee			GPS Latitude/Longitude	
				Start	End
Item	Vegetation			38.435385 °	38.435385 °
				-121.509577 °	-121.509577 °
DWR ID	DWR_MA0009_01_s_2012_211				
Comment Code					
V6 : Landscaping					
Inspector Comment

View of the landscaping on the landward side of the levee looking downstream. Spring 2016.

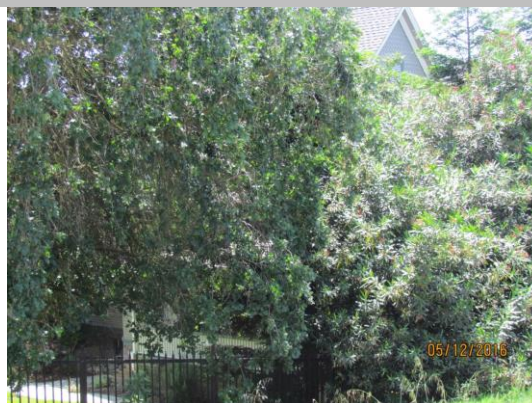
Photo 1 of 1 : FA\_2019\_MA0009\_201\_210\_20190904\_00134.jpg

LM Start	11.54	Rating **	M	Issue No.	210
LM End	11.55	Issue Type +	En	Location *	LS
Category	Earthen Levee			GPS Latitude/Longitude	
				Start	End
Item	Encroachments			38.434465 °	38.434413 °
				-121.512453 °	-121.512623 °
DWR ID	DWR_MA0009_01_s_2012_210				
Comment Code					
BU : Building					
Inspector Comment					
Building with some landscaping in front of it.

View of the building on the landward side of the levee. The building is behind the shrubs and at the toe of the levee. Spring 2016.

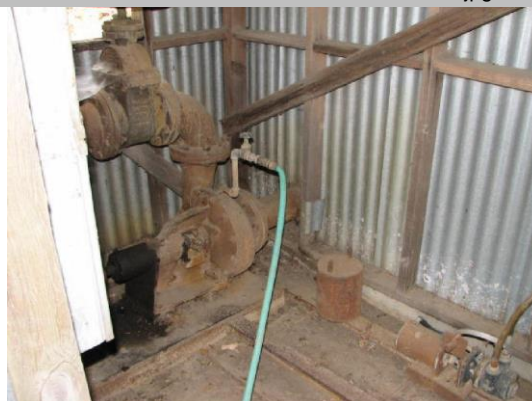
Photo 2 of 3 : UCIP\_FA\_2019\_5133\_6875.jpg

LM Start	11.66	Rating **	M	Issue No.	1816 (cont)	
LM End	11.66	Issue Type +	En	Location *		
Category	Supplemental			GPS Latitude/Longitude		
				Start	End	
Item	DRAFT DWR UCIP Field Study			38.434075 °	38.434075 °	
				-121.514687 °	-121.514687 °	
DWR ID	17461					
Comment Code						
Inspector Comment						
DS_ID:17461 FS_ID:5133 EP_NO: N/A Repair Type: Non-Urgent Crossing Status: Found UCIP Comments: excessive brush on WS slope prevents access to gate valve on WS slope. Remove brush. FIELD_STRUCT_DESC: 6-inch pipe through levee, 16.5 feet below crown. Pump in pump house at toe of landward slope. Could not locate the gate valve on waterward slope. Originally included in O+M manual (1955). FS Date: 6/22/2012 3:08:19 PM

Pump in pumphouse on LS toe.

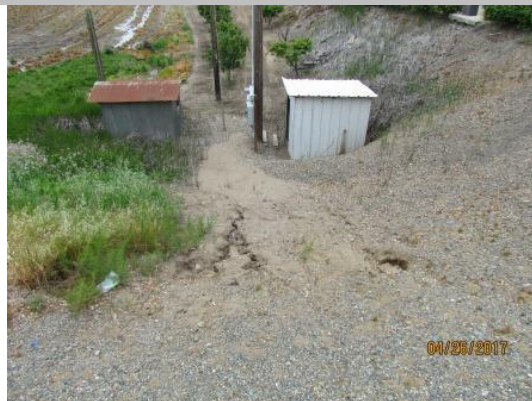
Photo 1 of 1 : FA\_2019\_MA0009\_201\_374\_20190904\_00265.jpg

LM Start	11.77	Rating **	A/W	Issue No.	374
LM End	11.77	Issue Type +	Ma	Location *	LS
Category	Earthen Levee			GPS Latitude/Longitude	
				Start	End
Item	Erosion / Bank Caving			38.433958 °	38.433958 °
				-121.516706 °	-121.516706 °
DWR ID	DWR_MA0009_01_s_2017_374				
Comment Code					
E2 : Schedule repair of erosion site prior to the next inspection.					
Inspector Comment					
Monitor runoff erosion on landside levee slope.

View of erosion on landside levee slope. Spring 2017.

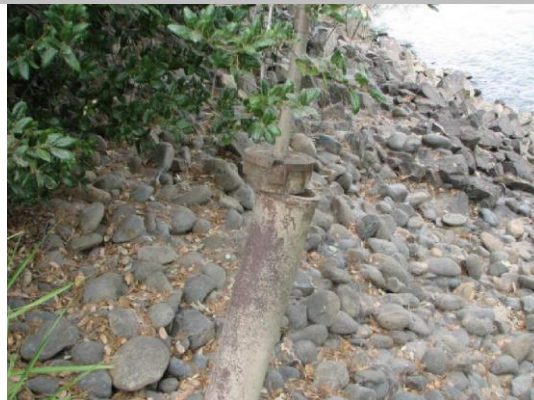
Photo 1 of 3 : UCIP\_FA\_2019\_5139\_6899.jpg

LM Start	11.78	Rating **	M	Issue No.	1817
LM End	11.78	Issue Type +	En	Location *	
Category	Supplemental			GPS Latitude/Longitude	
				Start	End
Item	DRAFT DWR UCIP Field Study			38.433998 °	38.433998 °
				-121.516790 °	-121.516790 °
DWR ID	17673				
Comment Code					
Inspector Comment					
DS_ID:17673					
FS_ID:5139					
EP_NO: N/A					
Repair Type: Non-Urgent					
Crossing Status: Found					
UCIP Comments: valve on WS slope does not close.					
FIELD_STRUCT_DESC: 2 of 2: 6-inch pipes through levee, 15.6 feet below crown. Pump and gate valve in pump house on landward side.					
Gate valve on WS slope. Originally included in O+M manual (1955).					
FS Date: 6/22/2012 3:31:00 PM

Broken or rusted valve on WS slope.

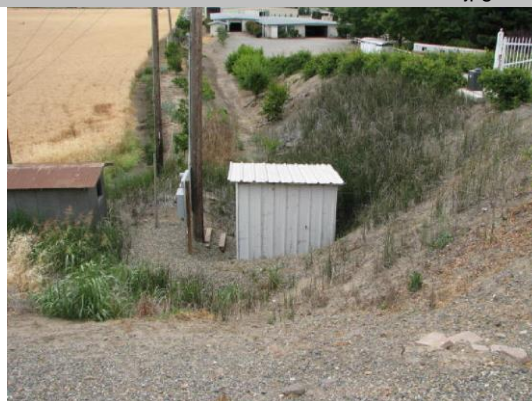
Photo 3 of 3 : UCIP\_FA\_2019\_5139\_6897.jpg

LM Start	11.78	Rating **	M	Issue No.	1817 (cont)	
LM End	11.78	Issue Type +	En	Location *		
Category	Supplemental			GPS Latitude/Longitude		
				Start	End	
Item	DRAFT DWR UCIP Field Study			38.433998 °	38.433998 °	
				-121.516790 °	-121.516790 °	
DWR ID	17673					
Comment Code						
Inspector Comment						
DS_ID:17673 FS_ID:5139 EP_NO: N/A Repair Type: Non-Urgent Crossing Status: Found UCIP Comments: valve on WS slope does not close. FIELD_STRUCT_DESC: 2 of 2: 6-inch pipes through levee, 15.6 feet below crown. Pump and gate valve in pump house on landward side. Gate valve on WS slope. Originally included in O+M manual (1955). FS Date: 6/22/2012 3:31:00 PM

Pumphouse on LS toe with JP and meter.

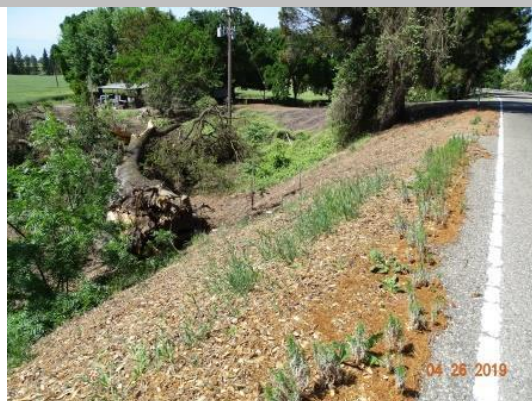
Photo 1 of 1 : FA\_2019\_MA0009\_201\_640\_20190904\_00299.jpg

LM Start	12.12	Rating **	M	Issue No.	640
LM End	12.12	Issue Type +	Ma	Location *	LS
Category	Earthen Levee			GPS Latitude/Longitude	
				Start	End
Item	Encroachments			38.434028 °	38.434028 °
				-121.523025 °	-121.523025 °
DWR ID	DWR_MA0009_01_s_2019_640				
Comment Code					
TR : Tree or limb					
Inspector Comment					
Remove large fallen tree from levee slope.

View of large fallen tree at levee toe. Spring 2019

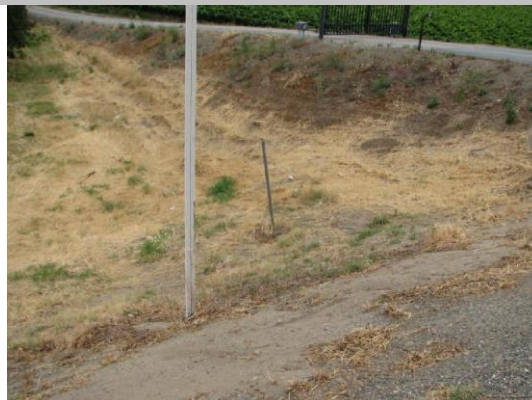
Photo 2 of 2 : UCIP\_FA\_2019\_41065\_6902.jpg

LM Start	12.29	Rating **	M	Issue No.	1818
LM End	12.29	Issue Type +	En	Location *	
Category	Supplemental			GPS Latitude/Longitude	
				Start	End
Item	DRAFT DWR UCIP Field Study			38.433945°	38.433945°
				-121.526154°	-121.526154°
DWR ID	17581				
Comment Code					
Inspector Comment					
DS_ID:17581 FS_ID:41065 EP_NO: N/A Repair Type: Non-Urgent Crossing Status: Indicator Found UCIP Comments: T post on WS slope and 2-inch galvanized steel pipe on LS toe may indicate ends of abandoned pipe. FIELD_STRUCT_DESC: 6-inch pipe through the levee. Pump on River side with gates on river side of levee have been removed. Originally included in O+M manual (1955). FS Date: 6/22/2012 3:50:00 PM

2-inch pipe on LS toe.

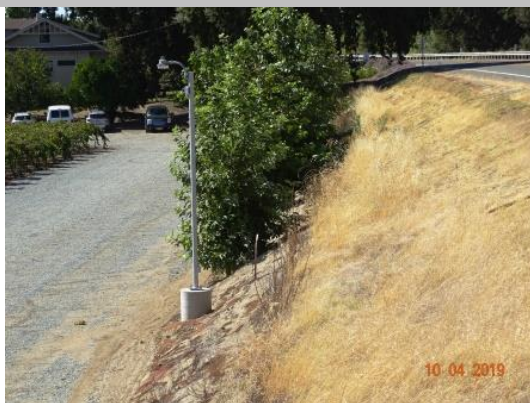
Photo 1 of 1 : FA\_2019\_MA0009\_201\_349\_20191010\_00549.jpg

LM Start	12.32	Rating **	M	Issue No.	349
LM End	12.37	Issue Type +	En	Location *	LS
Category	Earthen Levee			GPS Latitude/Longitude	
				Start	End
Item	Encroachments			38.433812 °	38.433675 °
				-121.526727 °	-121.527593 °
DWR ID	DWR_MA0009_01_f _ 2019_349				
Comment Code					
PO : Pole					
Inspector Comment					
Landowner installed four light poles and planted seven trees at the levee toe. FIR 7001 was submitted to the Board.

View of unauthorized light posts and trees at the landside toe. Fall 2019

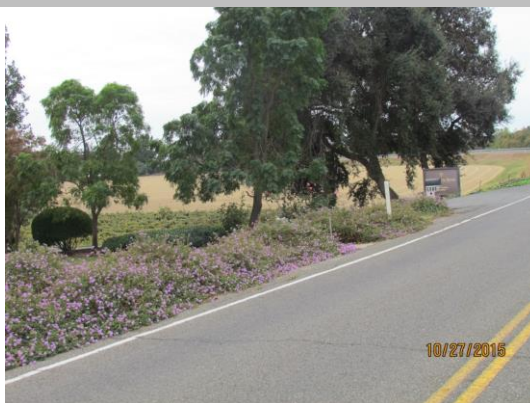
Photo 1 of 1 : FA\_2019\_MA0009\_201\_225\_20190904\_00142.jpg

LM Start	12.40	Rating **	M	Issue No.	225
LM End	12.41	Issue Type +	En	Location *	LS
Category	Earthen Levee			GPS Latitude/Longitude	
				Start	End
Item	Vegetation			38.433536 °	38.433505 °
				-121.528237 °	-121.528418 °
DWR ID	DWR_MA0009_01_s_2012_225				
Comment Code					
V6 : Landscaping					
Inspector Comment					
Ivy groundcover is not permitted.

View of the groundcover on the landward side of the levee looking downstream. Fall 2015.

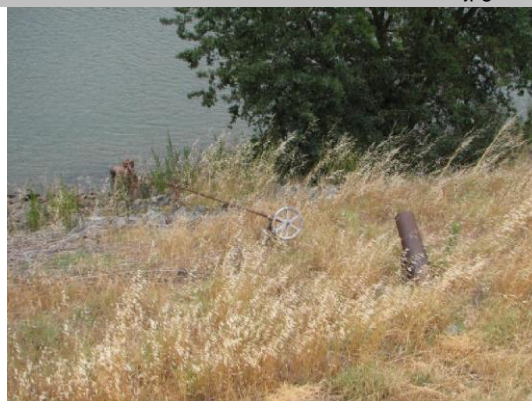
Photo 1 of 1 : UCIP\_FA\_2019\_5162\_6965.jpg

Comment Code						
Inspector Comment						
DS_ID:17453 FS_ID:5162 EP_NO: 8662 Repair Type: Non-Urgent Crossing Status: Found UCIP Comments: Further investigation is necessary to determine proper abandonment of this crossing. It is likely the 6-inch pipe on the WS is sleeved through an 8-inch steel pipe, but only the 6-inch is visible on the WS (see photo) FIELD_STRUCT_DESC: 8-inch steel pipe through levee, 9.0 feet below crown on LS. 6-inch steel pipe through WS slope 3.5 feet below the crown; grouted in place on WS. 1.5-inch steel conduit 3.5 feet below the crown next to 6-inch on WS slope. Power and service pole on landward slope. FS Date: 6/22/2012 8:51:49 AM

6-inch steel pipe grouted in place 3.5-feet below the crown.

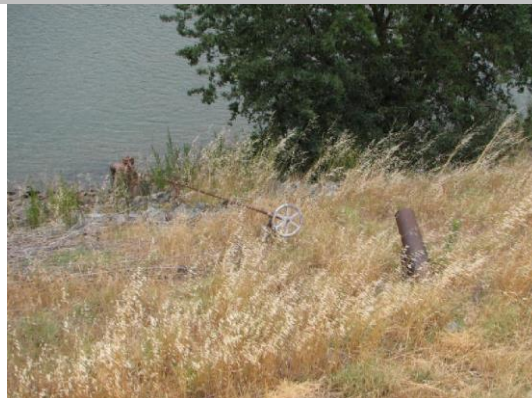
Photo 2 of 3 : UCIP\_FA\_2019\_53473\_20788.jpg

DS\_ID:16765  
 FS\_ID:53473  
 EP\_NO: 8662  
 Repair Type: Urgent  
 Crossing Status: Found  
 UCIP Comments: 08/24/2018 Crossing appears to be the same as the previous inspection. Crossing remains "Urgent" due to an unknown pipe condition through the levee. (A. McDonald - DWR UCIP)12/02/2016 Crossing is not abandoned both LS and WS have been modified since 2012. Need to contact owner to determine status of crossing. On the WS, a new pipe section was added or an existing pipe section has been repaired and painted. The LS pipe section, from pump house to distribution box, appears to have been updated since 2012. If crossing is active owner will need to coordinate with CVFPB to comply with Title 23. Unable to confirm if owner coordinated with CVFPB prior to the pipe modifications. Crossing remains Urgent due to the unknown condition of the pipe section through the levee, in 2012 during the last UCIP inspection the WS pipe showed holes through the pipe and required further evaluation to determine the condition of pipe through levee. Unable to confirm if owner replaced pipe through levee. (O. Magana - DWR UCIP)06/22/2012 Gate valve does not work and inspection does not show pipe as having been grouted in place. Further evaluation is necessary as there are corroded holes in pipe on WS of gate valve. (W. Wylie - DWR UCIP)

UCIP Comments: 08/24/2018 Crossing appears to be the same as the previous inspection. Crossing remains "Urgent" due to an unknown pipe condition through the levee. (A. McDonald - DWR UCIP)12/02/2016

Remote hand crank for gate valve at WS toe.

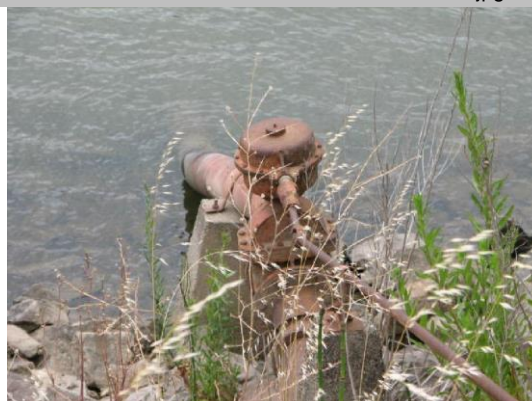
Photo 3 of 3 : UCIP\_FA\_2019\_53473\_20787.jpg

UCIP Comments: 08/24/2018 Crossing appears to be the same as the previous inspection. Crossing remains "Urgent" due to an unknown pipe condition through the levee. (A. McDonald - DWR UCIP)12/02/2016

Gate valve at WS toe.

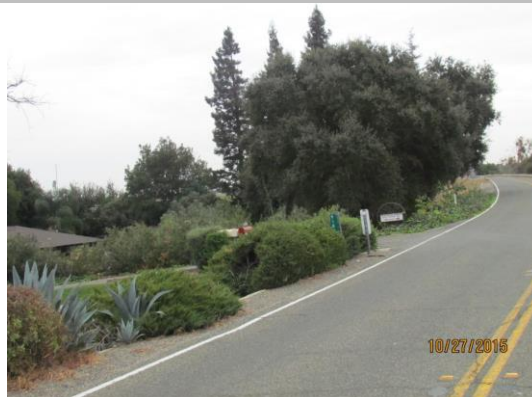
Photo 1 of 1 : FA\_2019\_MA0009\_201\_207\_20190904\_00133.jpg

LM Start	12.73	Rating **	M	Issue No.	207
LM End	12.77	Issue Type +	En	Location *	LS
Category	Earthen Levee			GPS Latitude/Longitude	
				Start	End
Item	Vegetation			38.430210 °	38.429643 °
				-121.531402 °	-121.531213 °
DWR ID	DWR_MA0009_01_s_2012_207				
Comment Code					
V6 : Landscaping					
Inspector Comment					
Remove century plants and ivy groundcover.

View of the landscaping on the landward side of the levee looking downstream. Fall 2015.

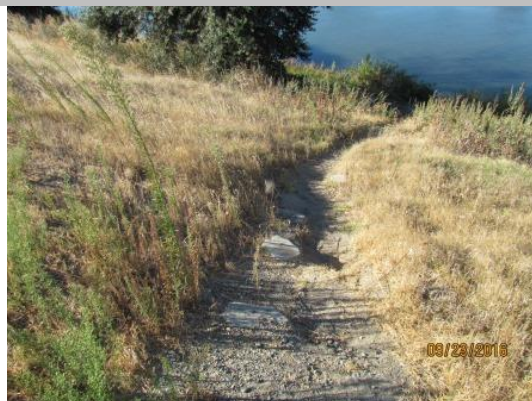
Photo 1 of 1 : FA\_2019\_MA0009\_201\_254\_20190904\_00180.jpg

LM Start	12.83	Rating **	A/W	Issue No.	254
LM End	12.83	Issue Type +	Ma	Location *	WS
Category	Earthen Levee			GPS Latitude/Longitude	
				Start	End
Item	Slope Stability			38.428881 °	38.428881 °
				-121.530829 °	-121.530829 °
DWR ID	DWR_MA0009_01_f_2016_254				
Comment Code					
S2 : Repair the levee slope damaged by foot traffic and prevent access where possible.					
Inspector Comment

Path made due to foot traffic. May cause slope stability issues. Stepping stones put in the ground. Fall 2016.

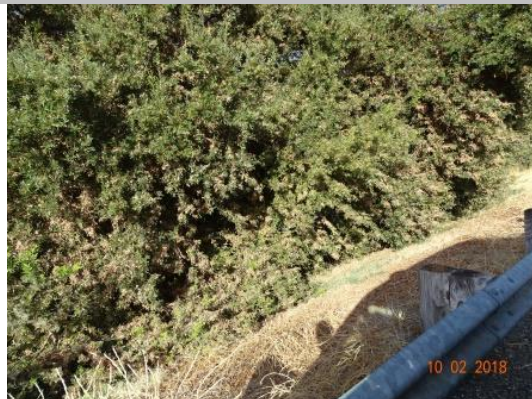
Photo 1 of 1 : FA\_2019\_MA0009\_201\_379\_20190904\_00268.jpg

LM Start	12.85	Rating **	M	Issue No.	379
LM End	12.85	Issue Type +	Ma	Location *	WS
Category	Earthen Levee			GPS Latitude/Longitude	
				Start	End
Item	Trim / Thin Trees			38.428578 °	38.428578 °
				-121.530670 °	-121.530670 °
DWR ID	DWR_MA0009_01_f_2018_379				
Comment Code					
T2 : Thin trees to allow visibility of the ground and room to flood fight.					
Inspector Comment

View of dense trees and brush that partially obstruct view of levee slope. Fall 2018

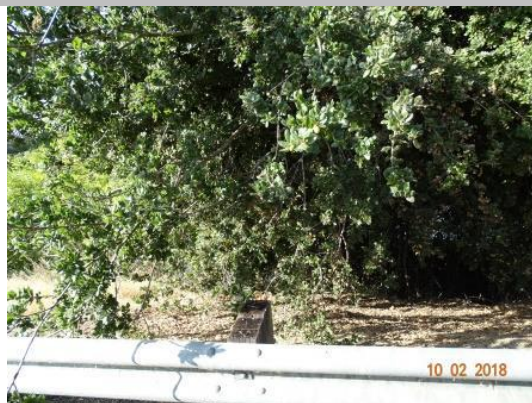
Photo 1 of 1 : FA\_2019\_MA0009\_201\_420\_20190904\_00282.jpg

LM Start	13.31	Rating **	M	Issue No.	420
LM End	13.31	Issue Type +	Ma	Location *	WS
Category	Earthen Levee			GPS Latitude/Longitude	
				Start	End
Item	Trim / Thin Trees			38.422883 °	38.422883 °
				-121.526293 °	-121.526293 °
DWR ID	DWR_MA0009_01_f_2018_420				
Comment Code					
T1 : Trim trees to at least five feet above ground level.					
Inspector Comment

View of tree limbs hanging over guard rail. Fall 2018

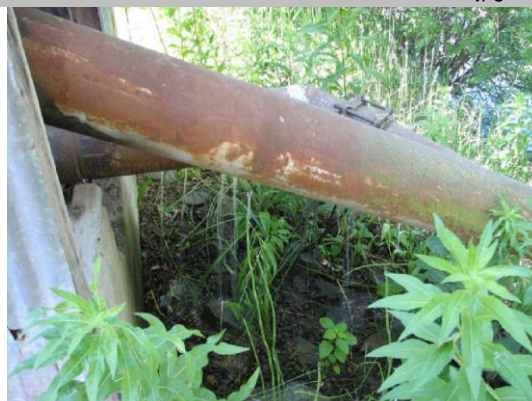
Photo 2 of 3 : UCIP\_FA\_2019\_53474\_20798.jpg

UCIP Comments: 08/24/2018 Same as previous inspection. Pipe sections laying on both sides of the levee. Crossing remains "Urgent" due to pipe integrity issues. Internal inspection by DWR DMP Phase 1 is recommended. Also need to contact the owner to determine if the pipe is active or not. (A. McDonald - DWR UCIP)12/02/2016 same as previous inspection recommend internal integrity inspection to determine condition of pipe through the levee. Need to contact owner to determine status of crossing. If crossing is still in use or is no longer in use, owner will need to coordinate with the CVFPB to comply with Title 23. (O. Magana - DWR UCIP)06/25/2012 Pipe has leaks between valve and levee crown on both sides of levee. Ineffective repairs have been made. This pipe is an excellent candidate for video inspection. (W. Wylie - DWR UCIP)

Holes/leaks in pipe on WS of Pumphouse.

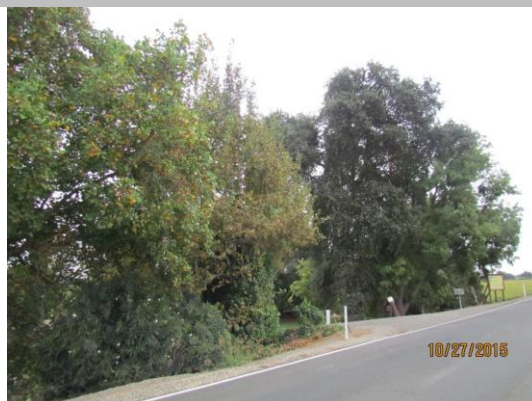
Photo 1 of 1 : FA\_2019\_MA0009\_201\_206\_20190904\_00132.jpg

LM Start	13.45	Rating **	M	Issue No.	206
LM End	13.45	Issue Type +	En	Location *	LS
Category	Earthen Levee			GPS Latitude/Longitude	
				Start	End
Item	Vegetation			38.421183 °	38.421183 °
				-121.524747 °	-121.524747 °
DWR ID	DWR_MA0009_01_s_2012_206				
Comment Code					
V6 : Landscaping					
Inspector Comment

View of the trees on the landward side of the levee looking downstream.  
Fall 2015.

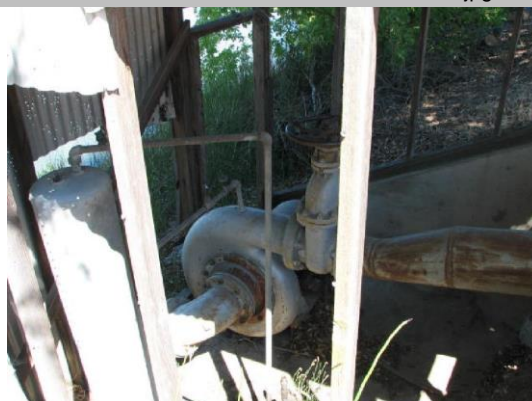
Photo 3 of 3 : UCIP\_FA\_2019\_5172\_6981.jpg

Item	DRAFT DWR UCIP Field Study			38.416180 °		38.416180 °
				-121.521083 °		-121.521083 °
DWR ID	17474					
Comment Code						
Inspector Comment						
DS_ID:17474						
FS_ID:5172						
EP_NO: N/A						
Repair Type: Non-Urgent						
Crossing Status: Found						
UCIP Comments: Rodent undermining pipe on LS slope. Need to fill burrow with flowable fill.						
FIELD_STRUCT_DESC: 14-inch pipe through levee, 5.2 feet below crown. 12-inch sleeved through 14-inch with annular space grouted. Pump and gate valve in pump house on waterward slope. Service pole on landward slope. 36-inch steel standpipe at toe of landward slope. Originally included in O+M manual (1955). 1.5-inch steel electrical conduit through levee and parallel to 14-inch pipe.						
FS Date: 6/25/2012 10:08:16 AM

Pump and gate valve in pumphouse on WS slope.

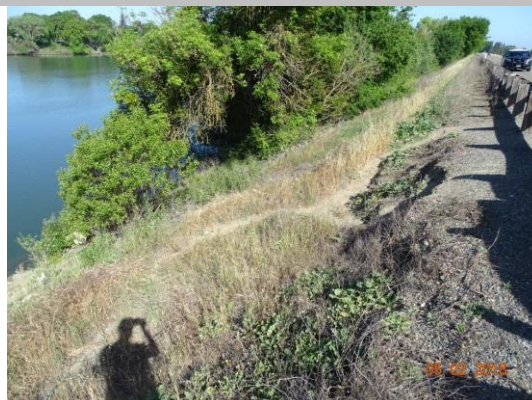
Photo 1 of 2 : FA\_2019\_MA0009\_201\_265\_20191010\_00544.jpg

LM Start	13.96	Rating **	M	Issue No.	265
LM End	13.96	Issue Type +	Ma	Location *	WS
Category	Earthen Levee			GPS Latitude/Longitude	
				Start	End
Item	Erosion / Bank Caving			38.414860 °	38.414860 °
				-121.520095 °	-121.520095 °
DWR ID	DWR_MA0009_01_s_2018_265				
Comment Code					
E2 : Schedule repair of erosion site prior to the next inspection.					
Inspector Comment					
Repair runoff and slope stability site. It appears to be an active fishing spot.

View of erosion site on waterside slope. Spring 2018

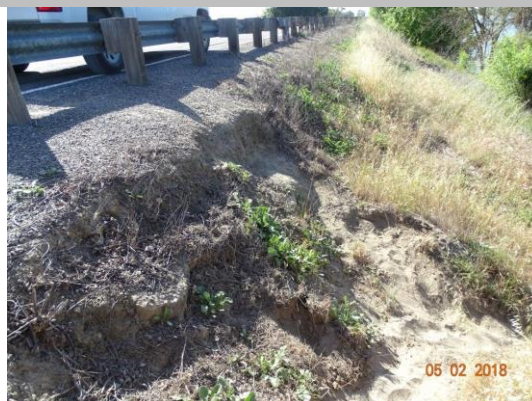
Photo 2 of 2 : FA\_2019\_MA0009\_201\_265\_20190904\_00184.jpg

LM Start	13.96	Rating **	M	Issue No.	265 (cont)	
LM End	13.96	Issue Type +	Ma	Location *	WS	
Category	Earthen Levee			GPS Latitude/Longitude		
				Start		End
Item	Erosion / Bank Caving			38.414860 °	38.414860 °	
				-121.520095 °	-121.520095 °	
DWR ID	DWR_MA0009_01_s _ 2018_265					
Comment Code						
E2 : Schedule repair of erosion site prior to the next inspection.						
Inspector Comment						
Repair runoff and slope stability site. It appears to be an active fishing spot.

Additional view of erosion. Spring 2018.

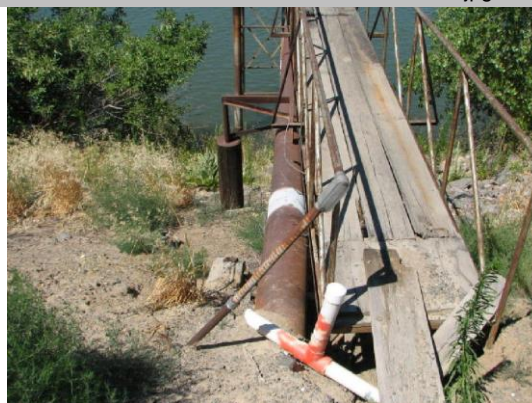
Photo 1 of 3 : UCIP\_FA\_2019\_5174\_6987.jpg

Comment Code					
Inspector Comment					
DS_ID:17475 FS_ID:5174 EP_NO: N/A Repair Type: Non-Urgent Crossing Status: Found UCIP Comments: Annular space between 12-inch and 14-inch pipes needs to be grouted. Siphon breaker on LS shoulder appears to be damaged. No permit identified for this crossing and it is not noted in the O+M manual. FIELD_STRUCT_DESC: 14-inch pipe through levee, 2.6 feet below crown. 12-inch pipe on WS connected to 14-inch pipe through levee. Pump on pile structure in stream. 1.5-inch steel electrical conduit through levee and parallel to 14-inch pipe. Siphon breaker in 24-inch CMP riser on LS shoulder. Pole, meter, and 36-inch concrete standpipe on LS toe. Permit No. 1835, 1953. FS Date: 6/25/2012 10:19:35 AM

12-inch steel pipe through 14-inch steel conduit on WS shoulder at pier.  
1.5-inch steel electrical conduit.

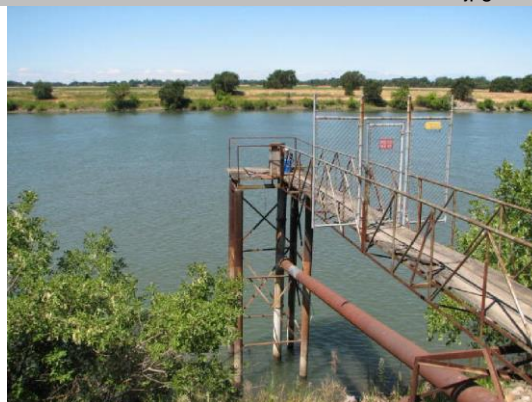
Photo 2 of 3 : UCIP\_FA\_2019\_5174\_6986.jpg

12-inch pipe on pier WS.

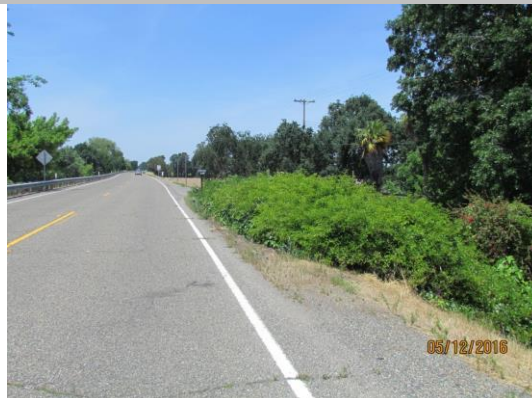
Photo 2 of 2 : FA\_2019\_MA0009\_201\_205\_20190904\_00131.jpg

LM Start	14.25	Rating **	M	Issue No.	205 (cont)	
LM End	14.27	Issue Type +	En	Location *	LS	
Category	Earthen Levee			GPS Latitude/Longitude		
				Start		End
Item	Vegetation			38.411162 °		38.410947 °
				-121.517383 °		-121.517202 °
DWR ID	DWR_MA0009_01_s_2012_205					
Comment Code						
V6 : Landscaping						
Inspector Comment

View of the shrubs on the landward side of the levee looking upstream. Spring 2016.

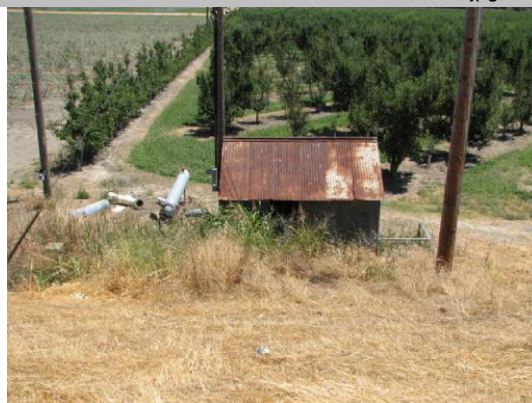
Photo 1 of 3 : UCIP\_FA\_2019\_53475\_6999.jpg

Comment Code						
Inspector Comment						
DS_ID:17466 FS_ID:53475 EP_NO: N/A Repair Type: Non-Urgent Crossing Status: Found UCIP Comments: 08/24/2018 Small pump inside the LS pump house was running. Crossing appears to be the same as last time. Crossing downgraded to "Non-Urgent" because there are no integrity issues or potential flooding issues during high water. (A. McDonald - DWR UCIP)04/26/2017 As per DWR inspector, Zack Jojola, the pump associated with this pipe appears to be leaking. Crossing has been upgraded from No Action Needed to Urgent. (K. Fazel - UCIP) FIELD_STRUCT_DESC: 12-inch pipe through levee, 10.5 feet below crown. Small pump inside a pump house at the LS toe. Filter outside the pump house. Originally included in O+M manual (1955). JP and meter at LS toe. FS Date: 8/24/2018

Pumphouse, JP, and meter on LS toe.

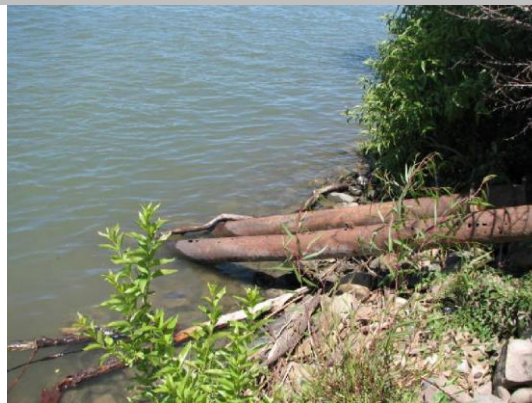
Photo 2 of 3 : UCIP\_FA\_2019\_53475\_6998.jpg

8-inch pipe and discarded 8-inch pipe on WS toe.

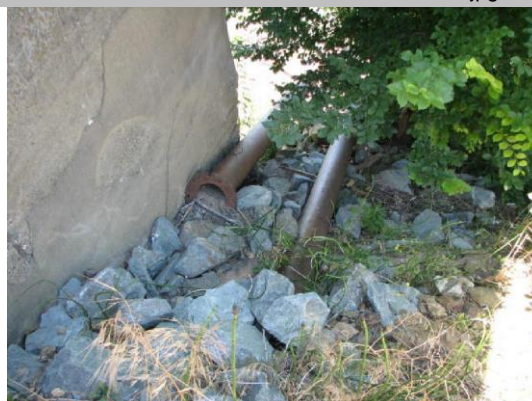
Photo 3 of 3 : UCIP\_FA\_2019\_53475\_7001.jpg

Item	DRAFT DWR UCIP Field Study			38.406118 °	38.406118 °	
				-121.514463 °	-121.514463 °	
DWR ID	17466					
Comment Code						
Inspector Comment						
DS_ID:17466						
FS_ID:53475						
EP_NO: N/A						
Repair Type: Non-Urgent						
Crossing Status: Found						
UCIP Comments: 08/24/2018 Small pump inside the LS pump house was running. Crossing appears to be the same as last time. Crossing downgraded to "Non-Urgent" because there are no integrity issues or potential flooding issues during high water. (A. McDonald - DWR UCIP)04/26/2017 As per DWR inspector, Zack Jojola, the pump associated with this pipe appears to be leaking. Crossing has been upgraded from No Action Needed to Urgent. (K. Fazel - UCIP) FIELD_STRUCT_DESC: 12-inch pipe through levee, 10.5 feet below crown. Small pump inside a pump house at the LS toe. Filter outside the pump house. Originally included in O+M manual (1955). JP and meter at LS toe.

8-inch pipe at US side of concrete pump house.

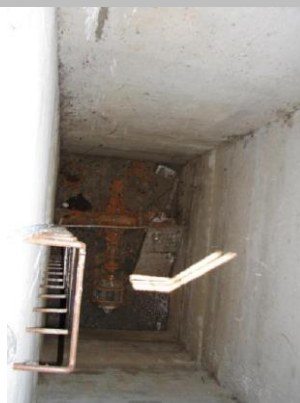
Photo 1 of 3 : UCIP\_FA\_2019\_53476\_6995.jpg

UCIP Comments: 08/24/2018 Small pump inside the LS pump house was running. Crossing remains "Urgent" due to the severely corroded pipe in the bottom of the pump house vault. What is the condition of the pipe through the levee? Recommend internal inspection through DWR DMP Phase 1. (A. McDonald - DWR UCIP)04/26/2017 As per DWR inspector, Zack Jojola, the pump associated with this pipe appears to be leaking. Crossing has been upgraded from No Action Needed to Urgent. (K. Fazel - UCIP)06/25/2012 Further evaluation should be conducted to determine if 12-inch pipe through levee has been properly abandoned. Pipe rusted through at bottom of pumphouse. (G. Wylie - FPIIB)

Pump, pipe, and gate valve at bottom of pit in pumphouse.

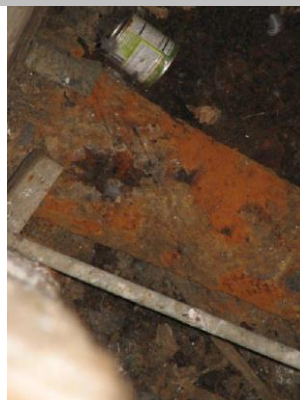
Photo 2 of 3 : UCIP\_FA\_2019\_53476\_6994.jpg

Pipe appears to be severely corroded at bottom of pumphouse pit.

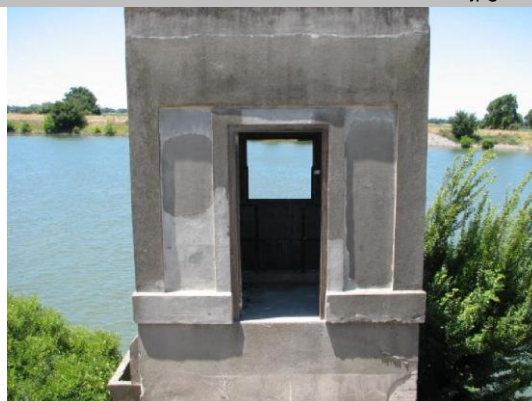
Photo 3 of 3 : UCIP\_FA\_2019\_53476\_6993.jpg

Item	DRAFT DWR UCIP Field Study			38.406099 °	38.406099 °	
				-121.514458 °	-121.514458 °	
DWR ID	17441					
Comment Code						
Inspector Comment						
DS_ID:17441 FS_ID:53476 EP_NO: N/A Repair Type: Urgent Crossing Status: Found UCIP Comments: 08/24/2018 Small pump inside the LS pump house was running. Crossing remains "Urgent" due to the severely corroded pipe in the bottom of the pump house vault. What is the condition of the pipe through the levee? Recommend internal inspection through DWR DMP Phase 1. (A. McDonald - DWR UCIP)04/26/2017 As per DWR inspector, Zack Jojola, the pump associated with this pipe appears to be leaking. Crossing has been upgraded from No Action Needed to Urgent. (K. Fazel - UCIP)06/25/2012 Further evaluation should be conducted to determine if 12-inch pipe through levee has been properly abandoned. Pipe rusted through at bottom of pumphouse. (G. Wylie - FPIIB) FIELD_STRUCT_DESC: 12-inch pipe through levee, 9.5 feet below crown. Concrete pump house with pump and gate valve at bottom of pit on WS slope. Steel plate welded on waterward end could not be verified or found. Small pump inside a pump house at the LS toe. Filter outside the pump house. Originally included in O+M manual (1955). FS Date: 8/24/2018

Pumphouse on WS slope.

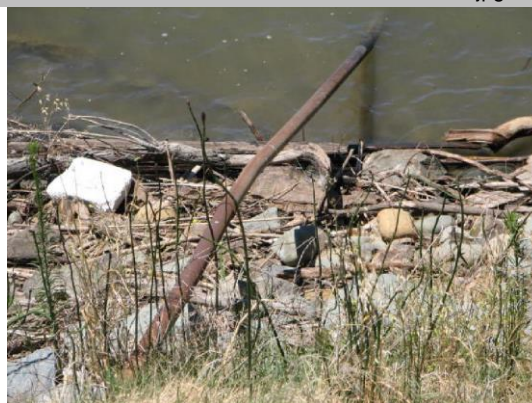
Photo 1 of 3 : UCIP\_FA\_2019\_51462\_20806.jpg

Comment Code						
Inspector Comment						
DS_ID:17464 FS_ID:51462 EP_NO: N/A Repair Type: Non-Urgent Crossing Status: Found UCIP Comments: 12/02/2016 Same as previous inspection. Need find owner. Owner will need to coordinate with the CVFPB to address what is currently logged as unauthorized encroachments. Owner will need to comply with Title 23. Dense vegetation limits the inspector's visibility to identify signs of pipe failure (leaks) along the slope. Recommend removing vegetation along pipe alignment to conduct proper inspection of structure and appurtenances. Crossing has been downgraded from "Urgent" to "Non-Urgent" due to modifications made to the UCIP repair/maintenance priority. (O. Magana - DWR UCIP)06/25/2012 No permit issued for this crossing and it is not an O+M entry. Abandoned pipe not grouted or sealed. (W. Wylie - DWR UCIP) FIELD_STRUCT_DESC: 2.25-inch steel water line through levee, 5 feet below crown. Gate valve located on the waterside (WS) slope has been removed. 2-inch steel pipe remains visible on the landside (LS) slope parallel to new 2.25-inch steel pipe. Pump house is located on the LS toe. [Additional Reference(s): DWR Levee Log, 1991]. FS Date: 12/2/2016

2.25-inch pipe at waterline.

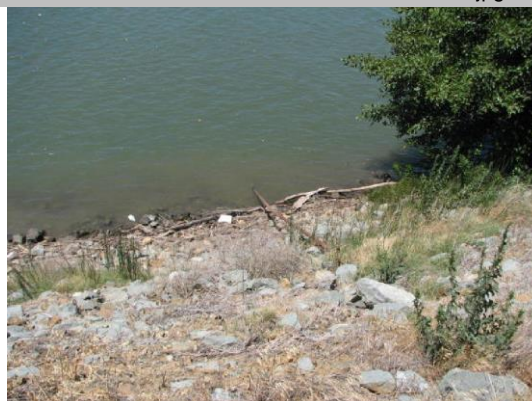
Photo 2 of 3 : UCIP\_FA\_2019\_51462\_20805.jpg

Item	DRAFT DWR UCIP Field Study			38.404834 °	38.404834 °	
				-121.513860 °	-121.513860 °	
DWR ID	17464					
Comment Code						
Inspector Comment						
DS_ID:17464 FS_ID:51462 EP_NO: N/A Repair Type: Non-Urgent Crossing Status: Found UCIP Comments: 12/02/2016 Same as previous inspection. Need find owner. Owner will need to coordinate with the CVFPB to address what is currently logged as unauthorized encroachments. Owner will need to comply with Title 23. Dense vegetation limits the inspector's visibility to identify signs of pipe failure (leaks) along the slope. Recommend removing vegetation along pipe alignment to conduct proper inspection of structure and appurtenances. Crossing has been downgraded from "Urgent" to "Non-Urgent" due to modifications made to the UCIP repair/maintenance priority. (O. Magana - DWR UCIP)06/25/2012 No permit issued for this crossing and it is not an O+M entry. Abandoned pipe not grouted or sealed. (W. Wylie - DWR UCIP) FIELD_STRUCT_DESC: 2.25-inch steel water line through levee, 5 feet below crown. Gate valve located on the waterside (WS) slope has been removed. 2-inch steel pipe remains visible on the landside (LS) slope parallel to new 2.25-inch steel pipe. Pump house is located on the LS toe. [Additional Reference(s): DWR Levee Log, 1991]. FS Date: 12/2/2016

View of pipe from WS shoulder.

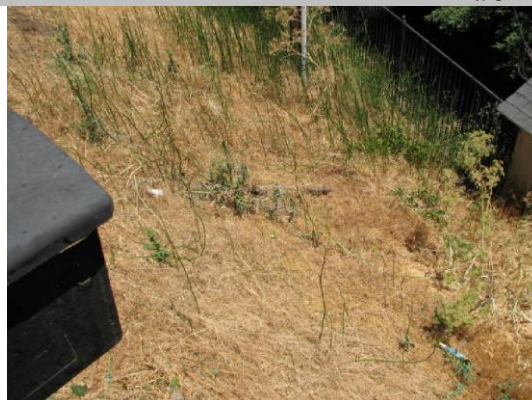
Photo 3 of 3 : UCIP\_FA\_2019\_51462\_20804.jpg

LS slope at pipe and pump house

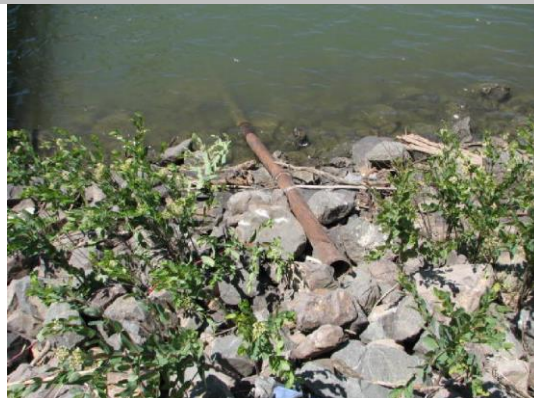
Photo 1 of 2 : UCIP\_FA\_2019\_5926\_9012.jpg

LM Start	14.75	Rating **	M	Issue No.	1828
LM End	14.75	Issue Type +	En	Location *	
Category	Supplemental			GPS Latitude/Longitude	
				Start	End
Item	DRAFT DWR UCIP Field Study			38.404510°	38.404510°
				-121.513690°	-121.513690°
DWR ID	18958				
Comment Code					
Inspector Comment					
DS_ID:18958 FS_ID:5926 EP_NO: N/A Repair Type: Non-Urgent Crossing Status: Found UCIP Comments: Pipe needs to be properly abandoned. FIELD_STRUCT_DESC: 4-inch cast iron sewer pipe through the levee, 18 feet below the crown. Located 9 feet upstream from the boat ramp walkway on the waterside (WS) slope. FS Date: 6/25/2012 3:51:21 PM

Pipe on WS slope at waterline. Pipe not backfilled with grout.

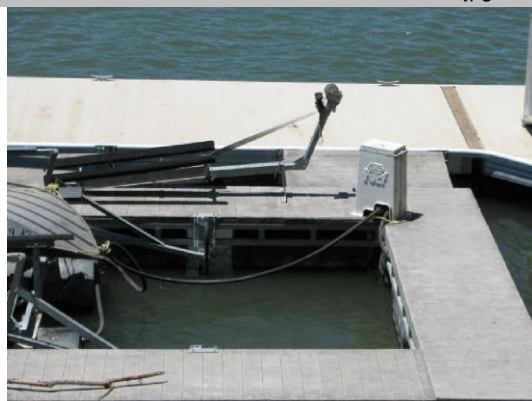
Photo 1 of 2 : UCIP\_FA\_2019\_5928\_9020.jpg

LM Start	14.76	Rating **	M	Issue No.	1829
LM End	14.76	Issue Type +	En	Location *	
Category	Supplemental			GPS Latitude/Longitude	
				Start	End
Item	DRAFT DWR UCIP Field Study			38.404480 °	38.404480 °
				-121.513680 °	-121.513680 °
DWR ID	18959				
Comment Code					
Inspector Comment					
DS_ID:18959					
FS_ID:5928					
EP_NO: N/A					
Repair Type: Non-Urgent					
Crossing Status: Found					
UCIP Comments: No permit identified for this crossing.					
FIELD_STRUCT_DESC: 1-inch polyvinyl chloride (PVC) electrical conduit through the levee, 1.5 feet below the crown, at the upstream side of the boat ramp walkway. Provides electrical service to boat ramp.					
FS Date: 6/25/2012 3:53:19 PM

Possible electrical conduit on boat dock.

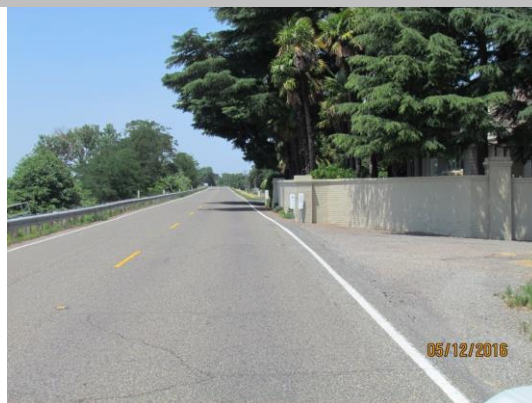
Photo 1 of 1 : FA\_2019\_MA0009\_201\_957\_20190904\_00305.jpg

LM Start	14.76	Rating **	M	Issue No.	957
LM End	14.76	Issue Type +	En	Location *	LS
Category	Earthen Levee			GPS Latitude/Longitude	
				Start	End
Item	Encroachments			38.404447°	38.404447°
				-121.513634°	-121.513634°
DWR ID	DWR_MA0009_01_s_2012_957				
Comment Code					
FE : Fence					
Inspector Comment					
Painted brick wall on landside shoulder.

View of the brick wall on the shoulder of the levee on the landward side looking upstream. Spring 2016.

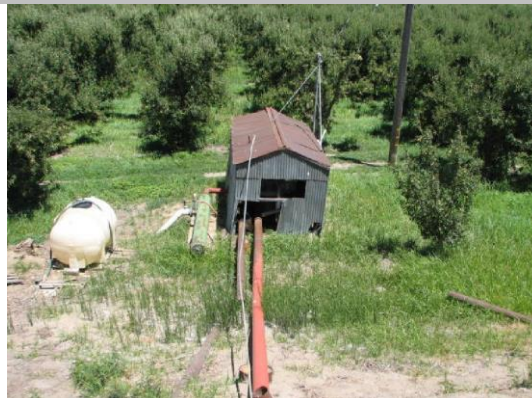
Photo 1 of 3 : UCIP\_FA\_2019\_5180\_7004.jpg

LM Start	15.04	Rating **	M	Issue No.	1830	
LM End	15.04	Issue Type +	En	Location *		
Category	Supplemental			GPS Latitude/Longitude		
				Start		End
Item	DRAFT DWR UCIP Field Study			38.400520 °		38.400520 °
				-121.512300 °		-121.512300 °
DWR ID	17429					
Comment Code						
Inspector Comment						
DS_ID:17429 FS_ID:5180 EP_NO: 6189 Repair Type: Non-Urgent Crossing Status: Found UCIP Comments: Need to determine if additional pipe on LS slope is discarded material or an additional pipe through the levee. FIELD_STRUCT_DESC: 5-inch pipe sleeved through 7-inch pipe through levee, 8.4 feet below crown. Annular space grouted, pump and gate valve in pump house on landward side (App. No. 6189 11/15/1968). Originally included in O+M manual (1955). 1-inch primer line runs to LS shoulder and 5-inch standpipe. FS Date: 6/25/2012 11:31:49 AM

Pumphouse, JP, and meter on LS toe. Showing 3 pipes on LS slope.

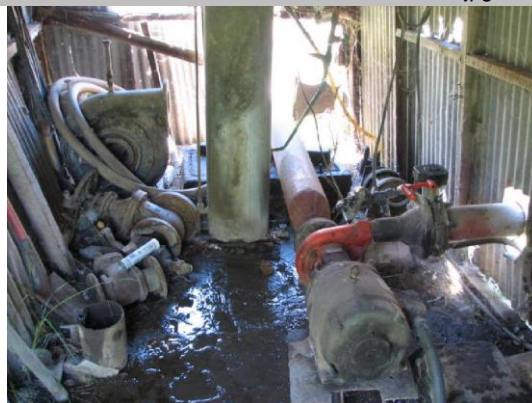
Photo 2 of 3 : UCIP\_FA\_2019\_5180\_7003.jpg

Pump in pumphouse on LS toe.
